BRE Global Test Report

Ad-hoc fire resistance test on a galvanised steel Tunnel Ventilation Damper employing procedures and criteria from BS 476: Part 20 : 1987.

Prepared for: Betec Cad Industries

Report Number: 302276 Issue: 1

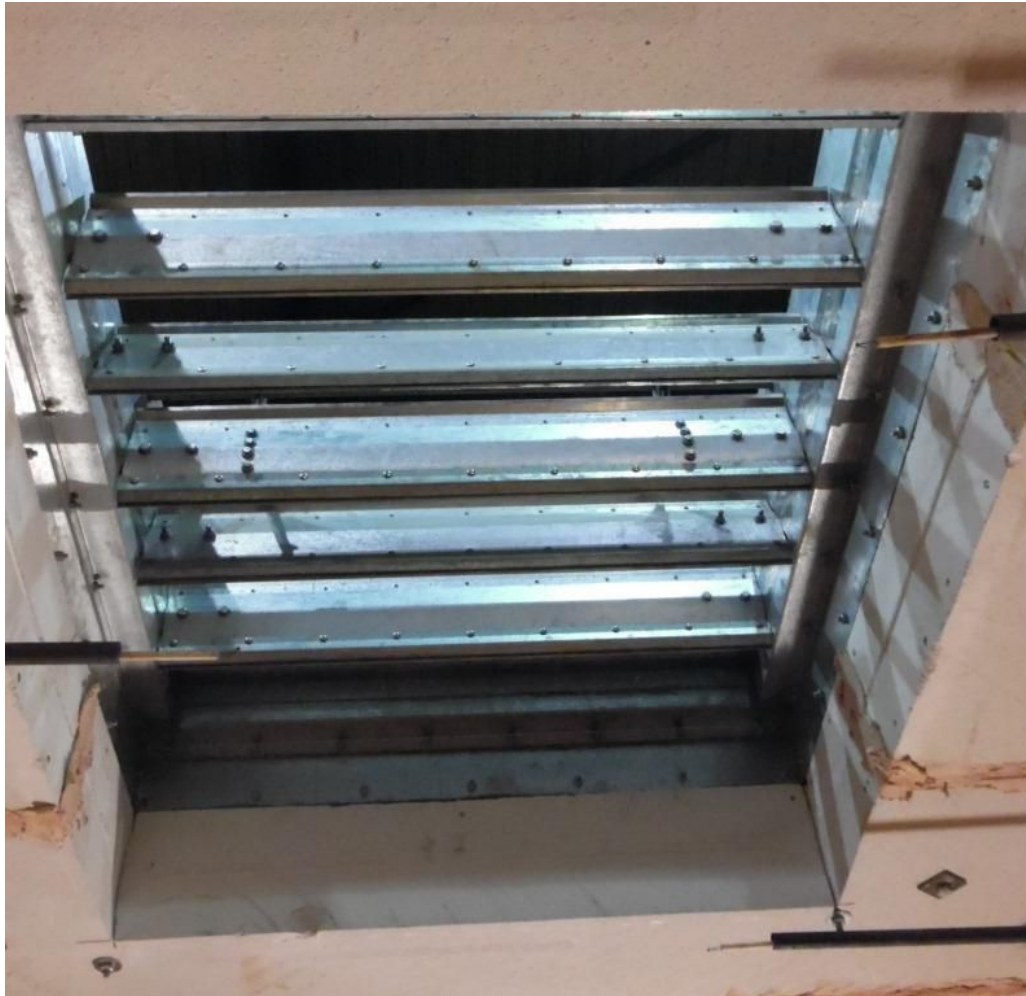
Photograph 1: Exposed face of the damper prior to test (open position).

The damper and actuator are shown before and after the test in *Photographs*.

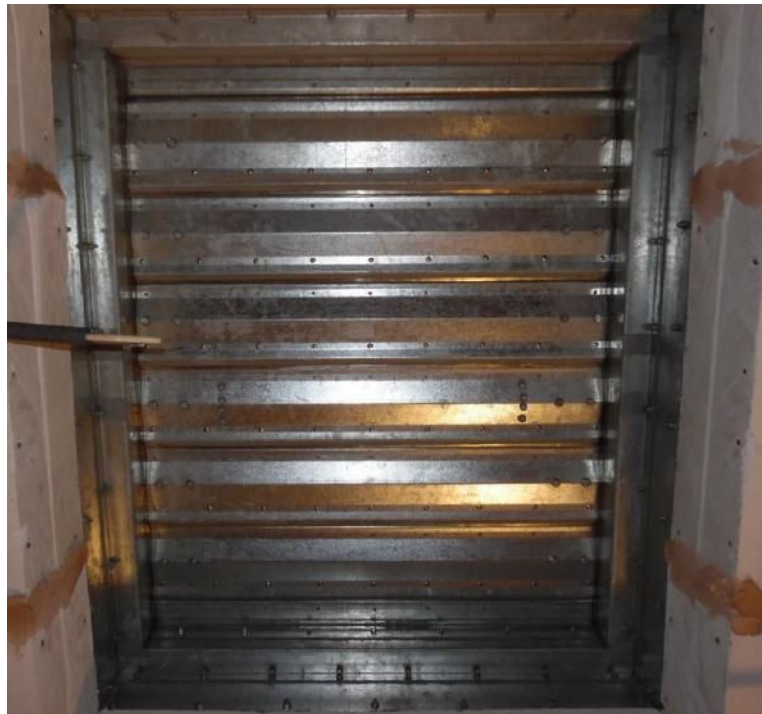
Photograph 2: Exposed face of the damper prior to test (closed position).

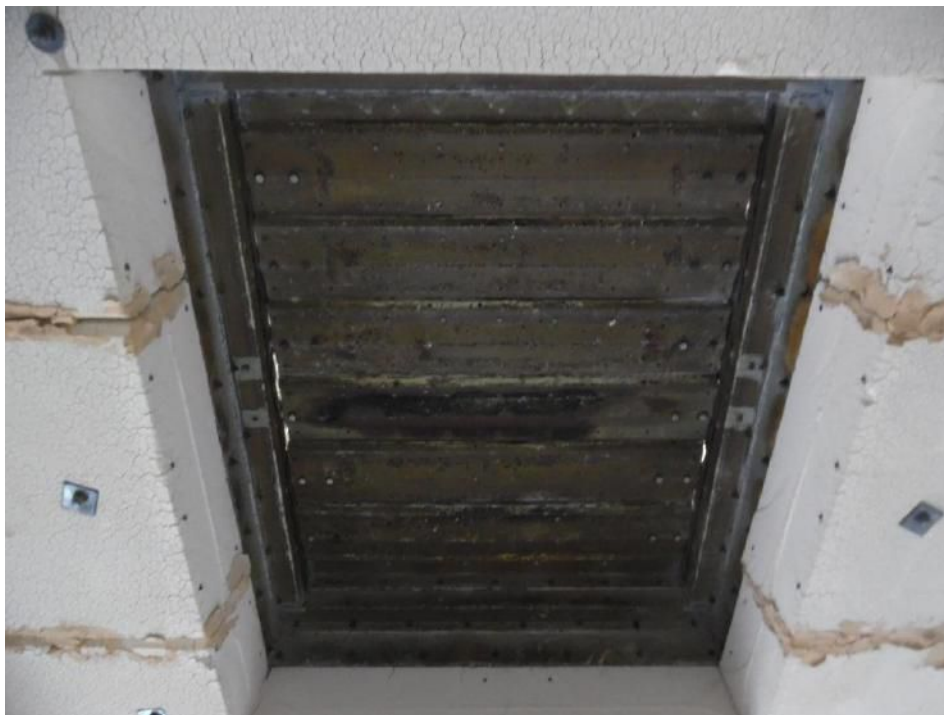
Photograph 3: Exposed face of the damper after test (closed position).

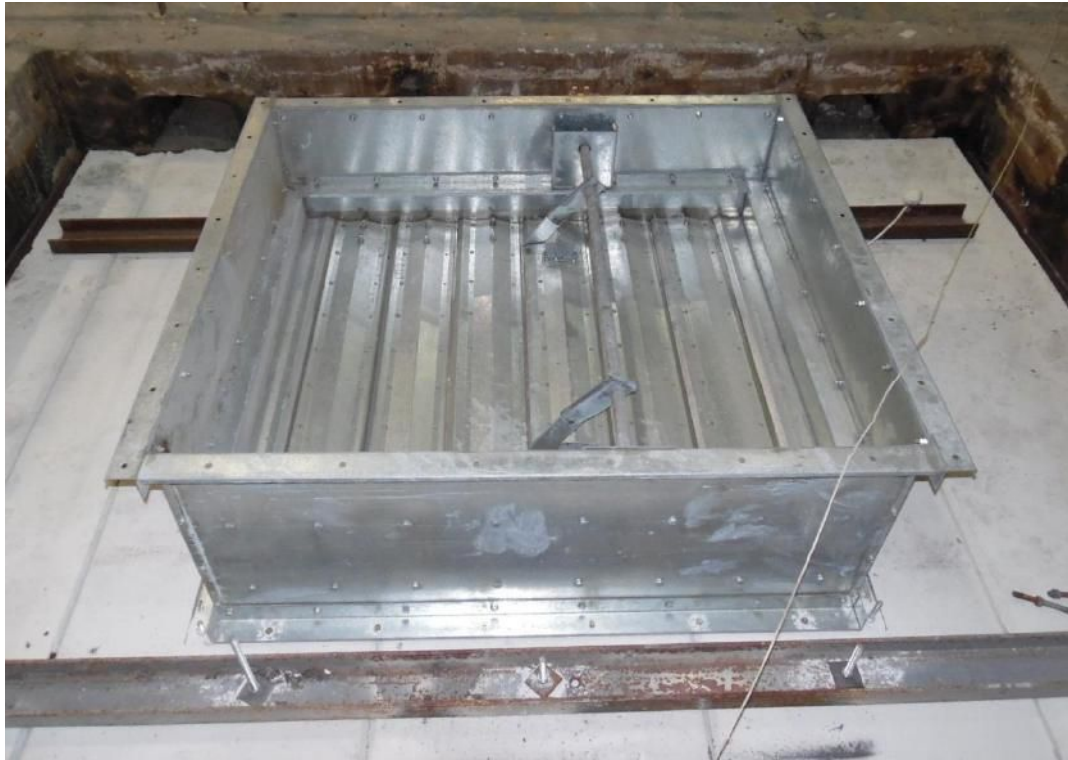
Photograph 4: Unexposed face of the damper prior to test (closed position).

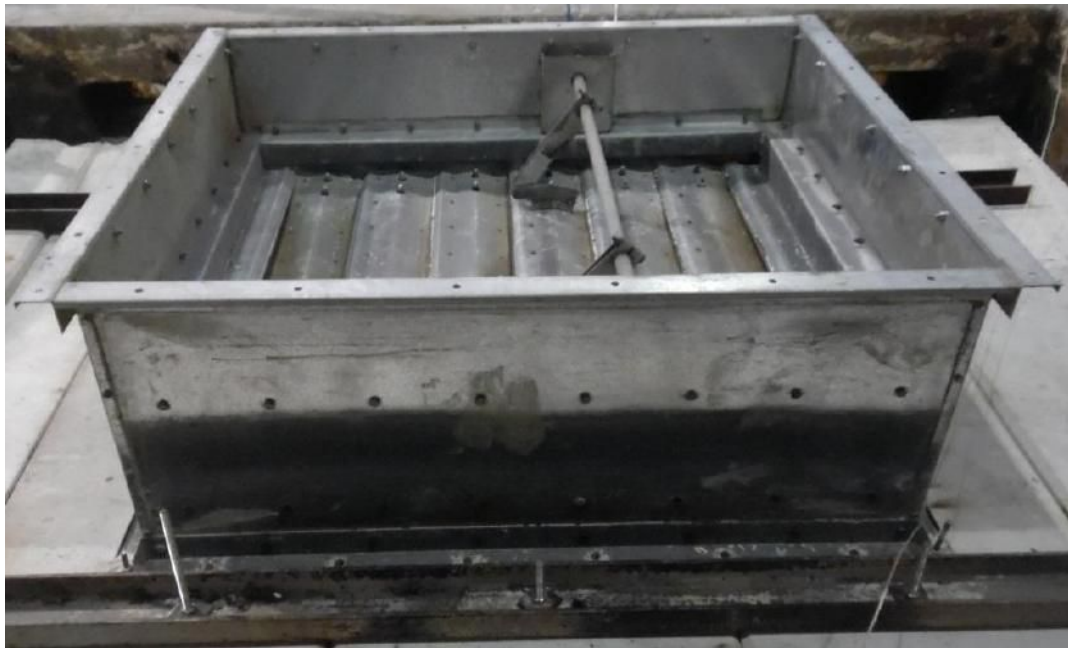
Photograph 5: Unexposed face of the damper after test (closed position).
